RIBBLE VALLEY BOROUGH COUNCIL

REPORT TO COMMUNITY SERVICES COMMITTEE

meeting date: TUESDAY, 10 JANUARY 2017
title: PLATFORM GALLERY URGENT WORKS
submitted by: JOHN HEAP – DIRECTOR OF COMMUNITY SERVICES
principal author: ADRIAN HARPER – HEAD OF ENGINEERING SERVICES

Condition Survey Photos

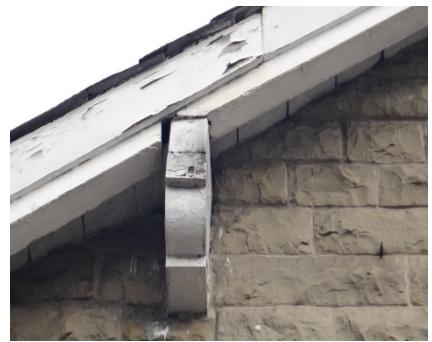
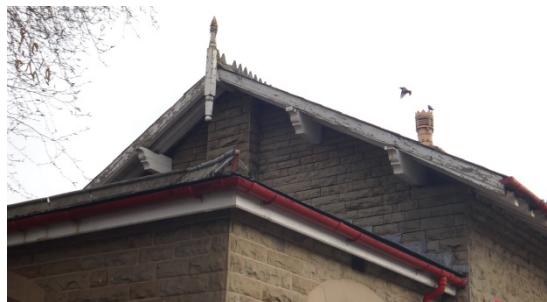
(B)

Some of the pictures below show examples of the damaged purlins not supporting the verges causing the ends of the roof to bow.

Purlins and spire North elevation, the paintwork to the barge boards is flaking and the exposed purlins are showing an extent of the decay. It can be seen from fig b that the purlin in this case isn't even supporting the roof structure

- 3.2 A decision was made to remove all rotten timber from end of roof purlins. Splice repair purlin ends and cut new timber to replicate existing profile. Where possible rotten timber was removed back to good timber and injected with epoxy resin compound shaped to existing profile. The timber fascias were sanded and prepared together with purlins and rafter ends and an exterior undercoat and gloss finish was applied.

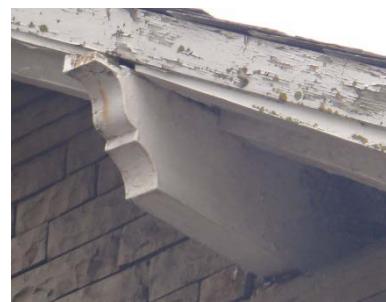
(D)

Purlins and spire South elevation, the barge boards are showing signs of decay and the purlins are showing severe water damage to the tops. Again fig D shows gasps between the verge and the purlin

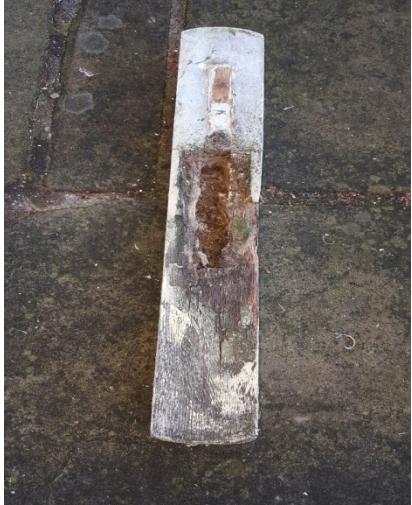
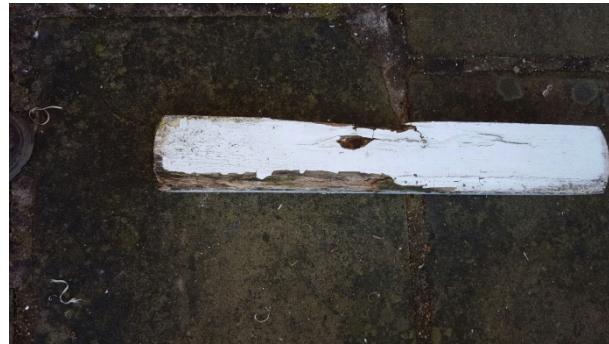
An example of the severity of the rot can be seen (fig E+F) the spire on the front elevation was leaning and could have fallen at any time.

The spire on east elevation is showing signs of significant rot. These members were so damaged that they were almost beyond repair. If they had been left then they could have fallen off, this was a significant health and safety risk. As you can see the spire was fixed by a Stub Tenon joint which was completely dilapidated

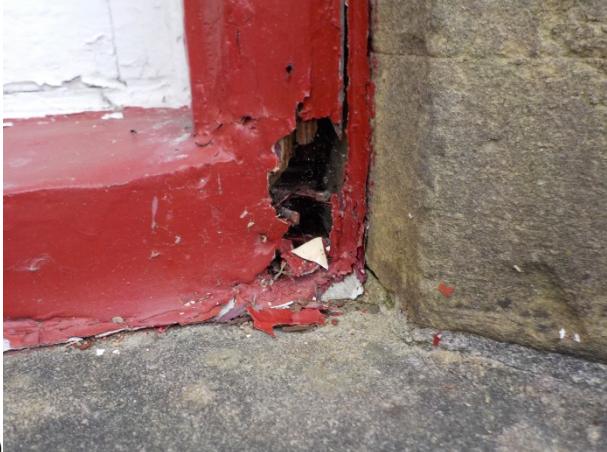
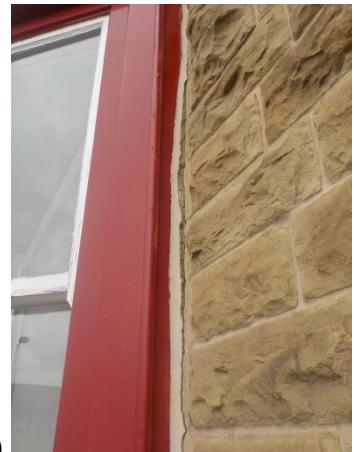
The windows and doors were also suffering from water damage; this mainly from capillary action as the water is soaked up by the wood. The sills and the lower side casing members were in poor condition due to years of exposure to the elements. This has caused some of the glass to drop in the frames and movement in the fabric of the bay windows. Some of the bay windows were being held in purely by the leadwork to the window. This was both a health and safety risk and a security risk and needed to be addressed before the winter.

Such was the extent of the rot in the bay window it had caused the window to drop, the downforce due to lack of support had caused a gap in the window frame and the wall. It can see from fig H that mortar around the window opening has been under pressure from the movement associated with the damage and lead work above was the only thing securing the window to the building.

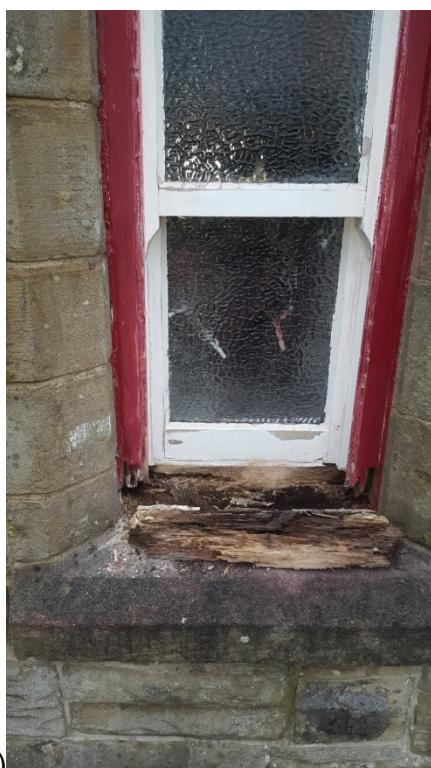
The sill has become so rotten that the remaining timber would have no loadbearing capabilities in relation to the window frame and would be a significant security issue.

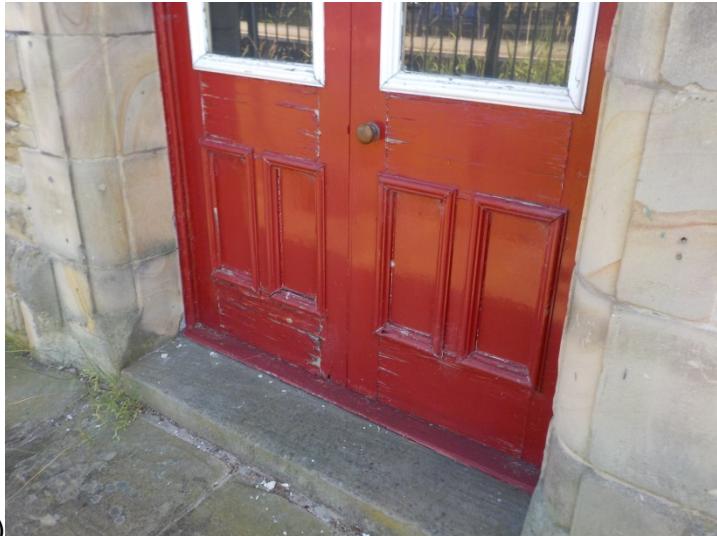
(J)

The sections of timber in the doors are so damaged that they would break up with very little force again this is a security issue.

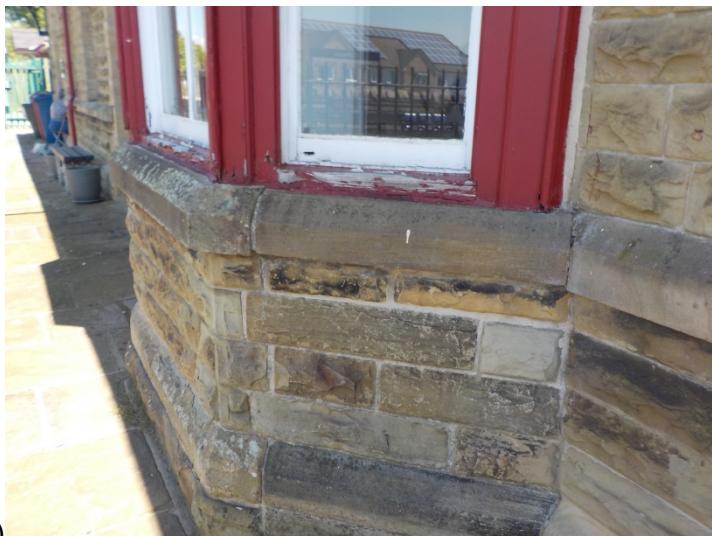
(K)

The sills and the lower side members were showing severe signs of decay.

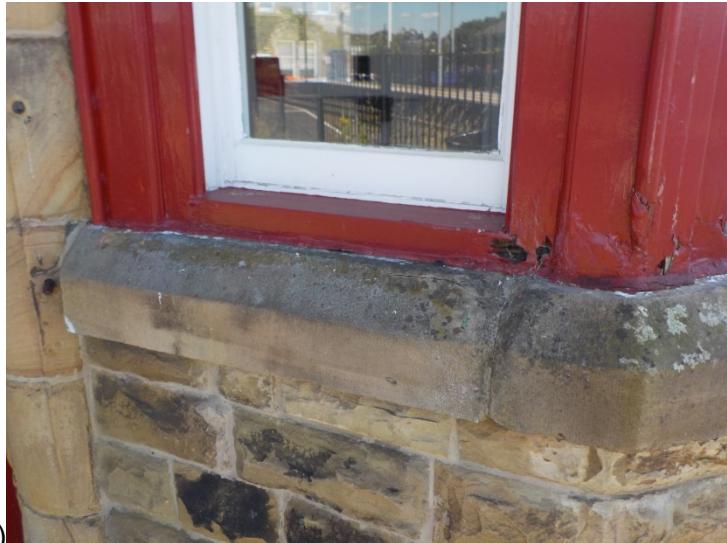
(L)

Severe signs of decay to the sill and side members, the timbers were evidently saturated and water staining was evident internally.
