# earthworks environmental design

16 December 2009

Bat inspection (Protected Species): Garage at Salthill Villa, Salthill Road, Clitheroe. BB7 1PE

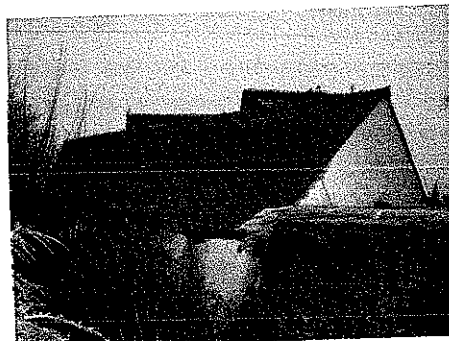
FIGURE 1:

You have requested an inspection of the above named property on behalf of your client Dr. C. Rothery to undertake a bat inspection as a condition of an application to the local planning authority for building alterations. It is understood the proposal involves demolition of the garage/utility building and construction of a two storey annex; the existing out-building are shown in figures 1 to 6 of this report. The structure has four distinct areas and these are shown in figure 1 (A – D)

The property is a detached out-building with standard brick construction and pitched timber-framed roof with an enclosed roof void. There are 4 separate areas (as shown in figure 1) as follows:
