# Bat Roost Assessment Report

8 Back Lane,  
Rimington,  
BB7 4EL

14.08.2019

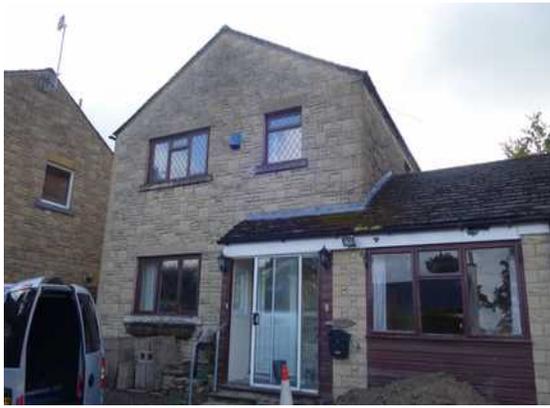
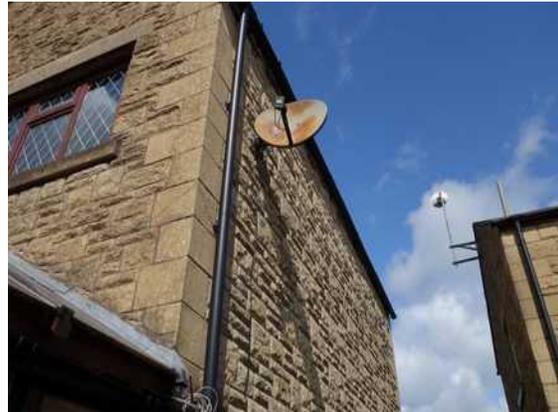
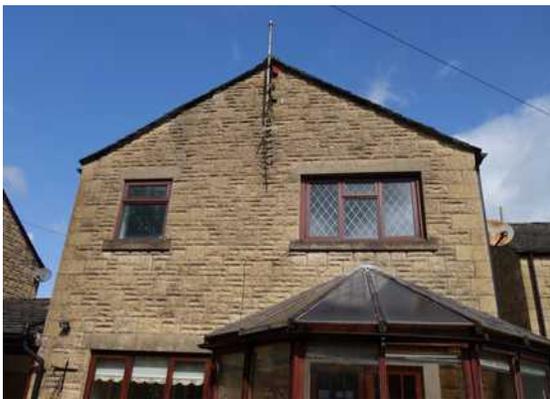
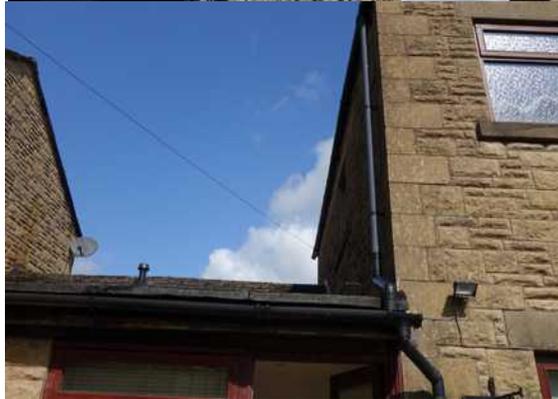
The property consists of a semi-detached stone built two storey house with double pitched tiled roof. External walls are pointed and in good general condition, with well pointed gable ends. Roof tiles are close fitting with ridge tiles pointed and well sealed. Fascia boards are close fitting.

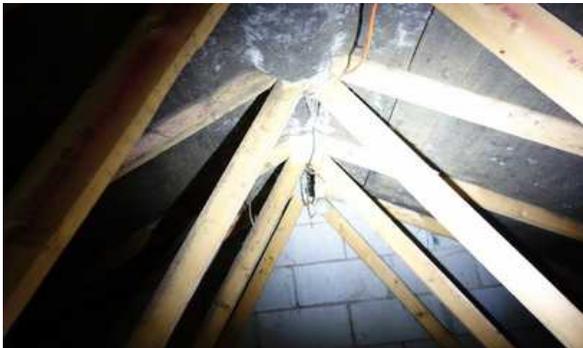
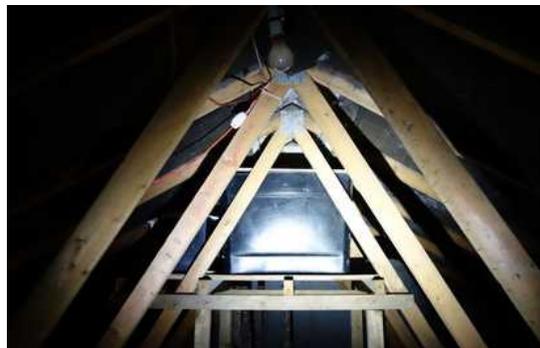
Loft spaces are well insulated with a bituminous roofing felt below roof tiles. Roofing felt along the ridge has rotted and is hanging loose leaving the ridge underside exposed.

The property was observed to be well sealed with a single gap below the ridge tiles on the southern gable suitable for use by roosting bats. Some aged droppings on ripped roofing felt suggested historic evidence of use by bats prior to deterioration of roofing felt below the ridge. An inspection of remaining roofing felt via endoscope found no further evidence of use and no fresh or recent droppings were observed.

It is considered that the building had historic use by pipistrelle sp bats roosting between ridge tiles and roofing felt. Deterioration and rotting of the roofing felt has led to the abandonment of the roost at some point in the last five or more years. Droppings present were dry, grey and decayed almost to the point of dust, typical of old droppings and suggesting abandonment due to loss of the roost feature. The rest of the roof is well sealed offering no other potential roost features.
